Case Report

Tyre-blast injuries

O.P. Murty MBBS MD (Professor Forensic Pathology)*

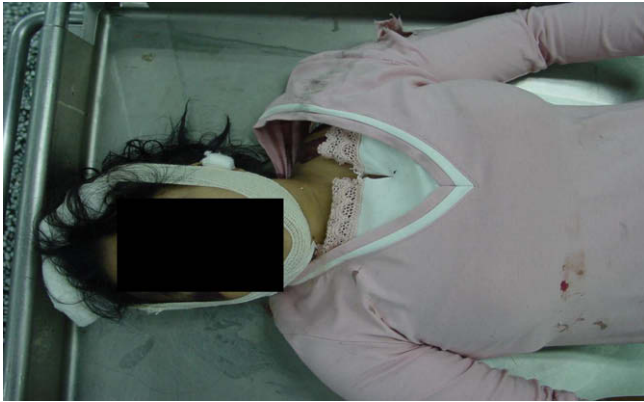
Fig. 1. Torn T-shirt due to air-blast impact, grease and dirt over left front area, rest clothing intact and clean.

On postmortem examination, body of young female, had rigor mortis present all over the body, postmortem lividity faintly present over the back and dependent parts of the body in supine position. The face and head were tied with white bandage (Fig. 1) bleeding from right ear, trouser clean. There was abraded contusion over the right side of face and oozing of blood from right ear (Fig. 2). There was confluent abraded bruise over left shoulder and upper back adjoining shoulder area (Fig. 3) and part of upper limb and an abraded area in the lower back of abdominal area. A lacerated wound of size 8 × 4 cm was present on the occipital region with diffuse sub scalp haematoma and a gaping fissure

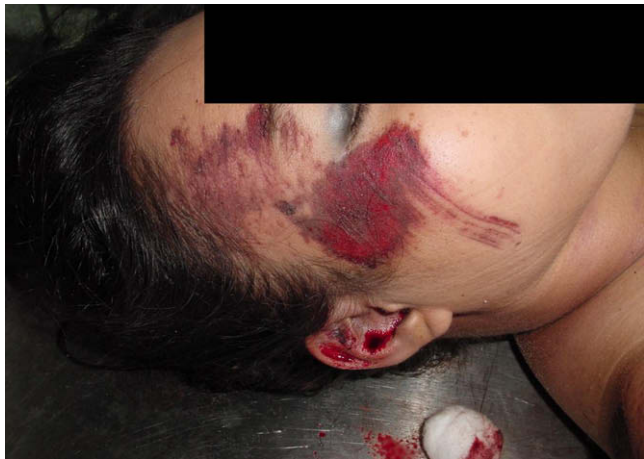
Fig. 2. Abraded area over right-side face and forehead with bleeding from ear.

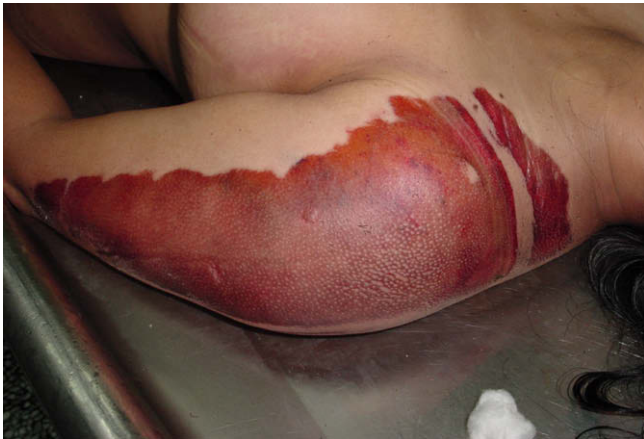
Fig. 3. Abraded area over left shoulder and upper arm.

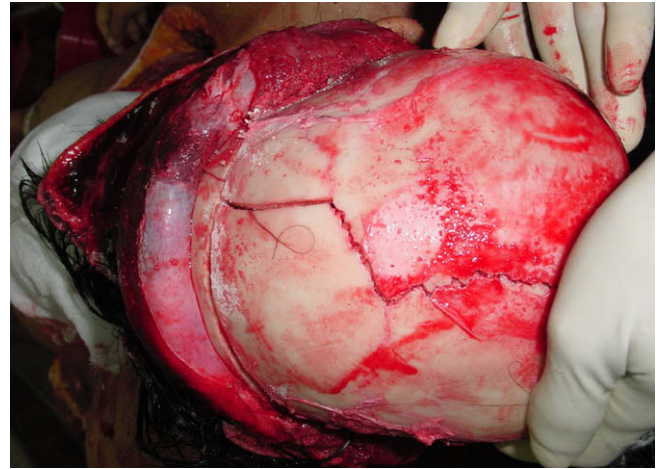
Fig. 4. Fractured skull over vertex and frontal area with visible contused scalp.

fracture running from occipital area to posterior clinoid process in the mid brain (Figs. 4 and 5). On internal examination diffuse subdural haematoma was present over entire brain surface and large subarachnoid haemorrhage was also present over both cerebral hemispheres and basal areas.

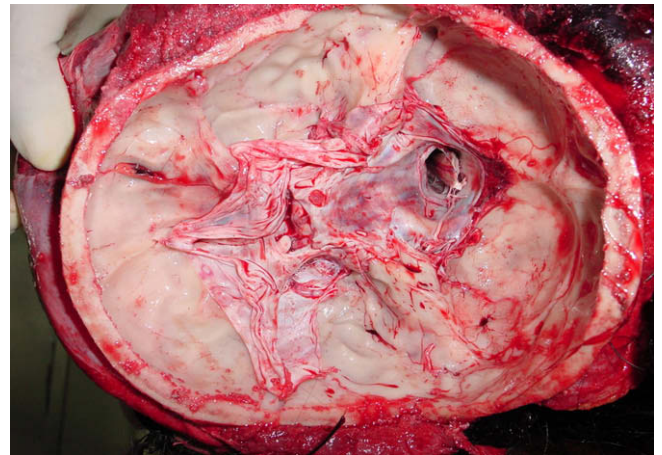
Fig. 5. Long skull fracture extending to posterior clinoid processes. Skull bones were very thick still impact was so severe that caused fissure fracture.

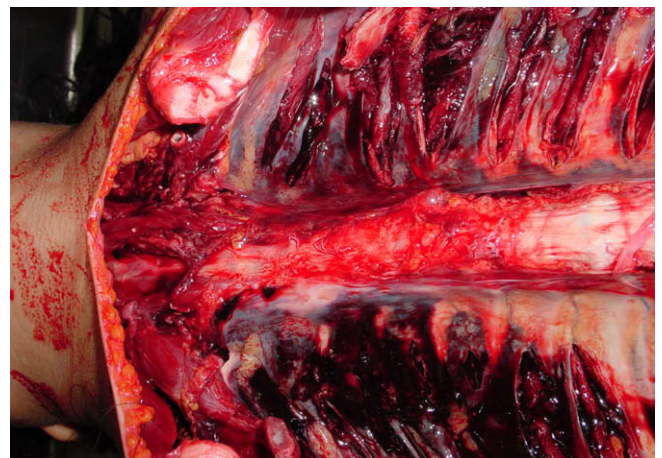
Fig. 6. Bilateral contusions with fractures of ribs (exposed by postmortem incisions).

The chest cavity was full of blood (about 1.5 l) on both sides. Both side chest walls showed diffuse contusion and rib fractures in mid-clavicular and para vertebral areas posteriorly (Fig. 6). Lungs were partly collapsed and showed contusion and laceration on posterior and sides of the lobes (Fig. 7). These were due to combined effect of high pressure and probably raised pavement side and rough road surface which contributed in the causation of injuries. The diffuse abraded areas on the shoulder and side of the face were caused by rough road surface. In this case, eye witnesses accounted flying of the girl about 2 ft and then falling on the road about 3 ft away from the blasted tyre.

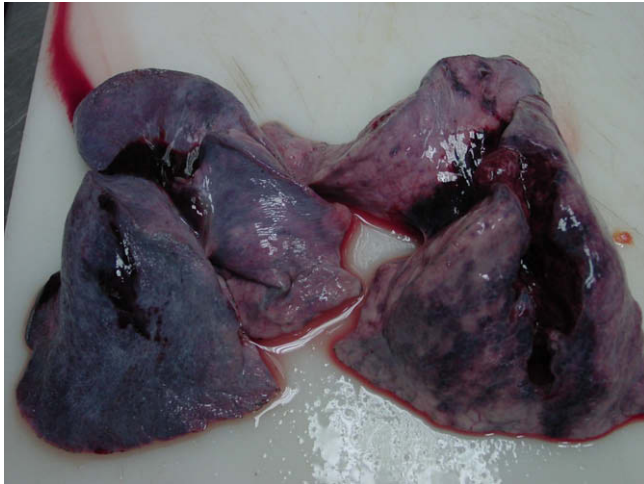
Fig. 7. Contused, punctured, lacerated and partly collapsed lungs.

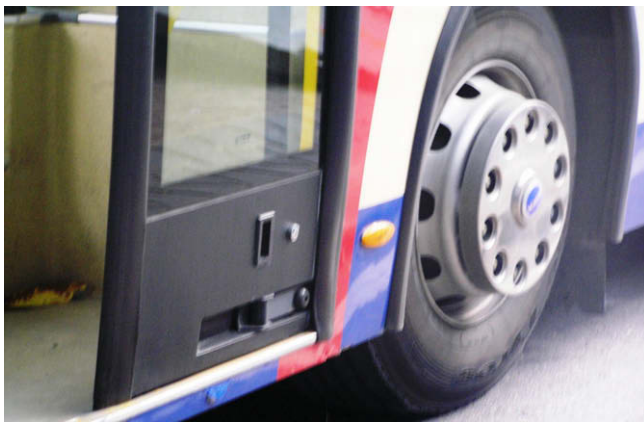
Fig. 8. Repositioned tyre of the bus showing wheel and iron rim. In this case, when bus was seen the tyre was already repositioned in place of burst tyre. So exact nature of tears and rim damage could not be assessed.

An 18-year-old female of stout build, was waiting on the bus stand to catch bus to her college in the early morning hours. The wheel of public transport bus burst and caused her death. A complete medico-legal autopsy was performed on her at PPUM hospital Kuala Lumpur. This fatality by burst tyre of a public transport is reported here in detail with injury photographs [1–7] and repositioned wheel is shown in Fig. 8.

A standard inflated tyre-tube explosion has sufficient force to lift a passenger vehicle three meters off the ground and result in the death of the person facing it. A tyre must be inspected for side-wall cracks, distortions, wrinkles, discoloration, repairs prior to any recent inflation. The eyes can be injured by high-velocity air and dust particles, oil and other debris. An exploding wheel is a high-speed projectile that can kill or maim anyone in its path. The air blast alone can cause injury and hearing loss. In such situations risks are from: compressed air, exploding or disintegration of wheels and tyres, and noise. This case has highlighted the seriousness of burst- tyre accident. This case also highlights the danger of pressurized tyres which are usually presumed as 'minor' explosion. It also emphasizes the need for thorough examination in the accident emergency department in such blast victims.
